GLADES DAM

NDI No. PA 00804  
PennDER No. 10-72

PHASE I INSPECTION REPORT  
NATIONAL DAM INSPECTION PROGRAM

AUGUST 1979

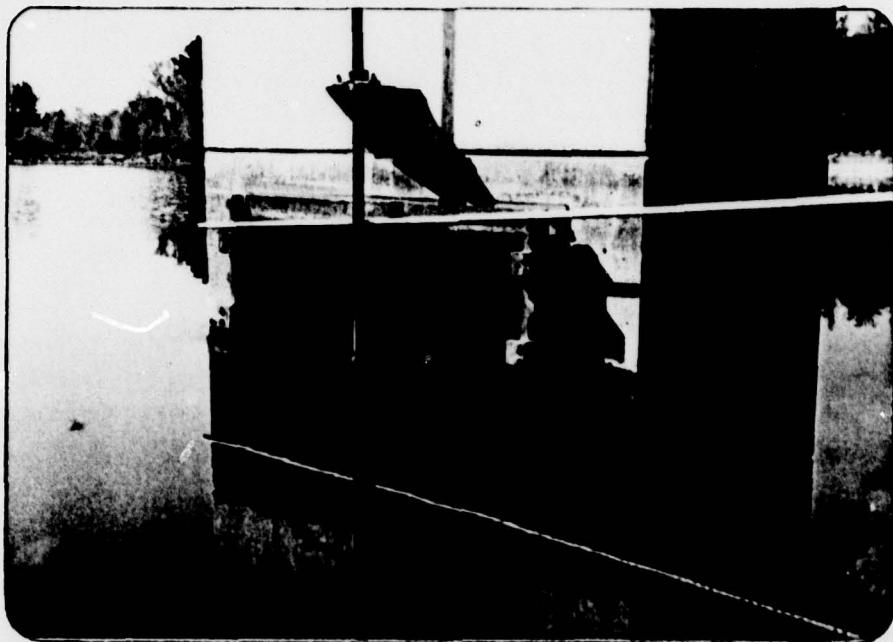
**PHOTO 5. Close-up View of Three Foot by Five Foot Intake at El. 1197.0 feet**  
(The sluice gate was designed to be in the inverted position.)
